Manhole Inspection Summary

Manhole # S35Y1_023MH

Insp Date: **8/6/08 3:40 PM**

Location Address: **20 Potee st**

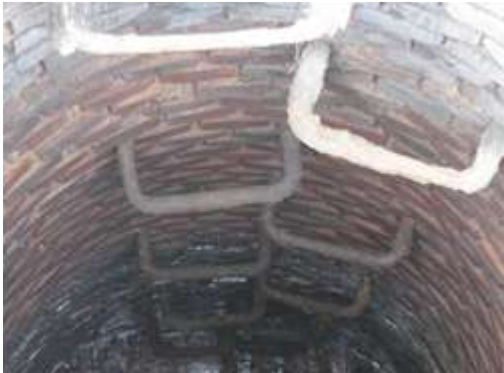
Steps Count: **10** Missing: **0** ☒ **Corroded**

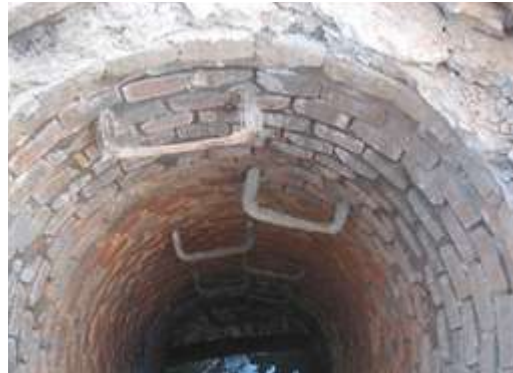
Defect 1

corroded step

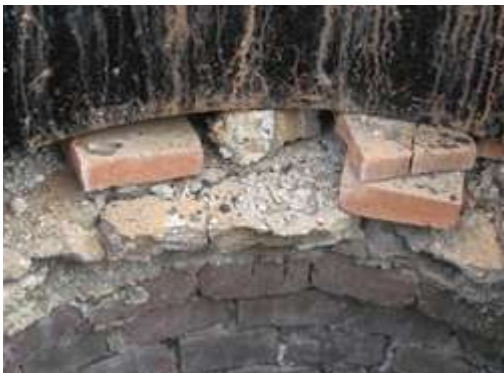
Defect 1

Condition: ☐ Sound ☒ **Cracked** ☐ Root Intrusion ☐ Loose Brick ☒ **Deteriorated**

Frame-Chimney Joint.

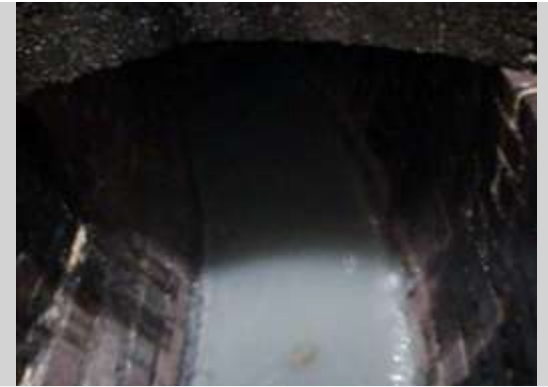
12 O'Clock Outflow

24 in. Circular Gravity Sewer
Pipe Out @ 12 O'Clock

Pipe Height: **30** (in.) Rod and Bar (Angled)
Pipe Material: **Unknown** ☐ Pipe Lined
Invert Depth: **18.34** (ft.) Flow Characteristics: **Slow**
Deposits: ☒ None ☐ Mud ☐ Sludge ☐ Debris ☐ Grease
Silt Depth: (in.) Deposits Extent:
Infiltration: **None** Pipe Seal Cond: **Sound**

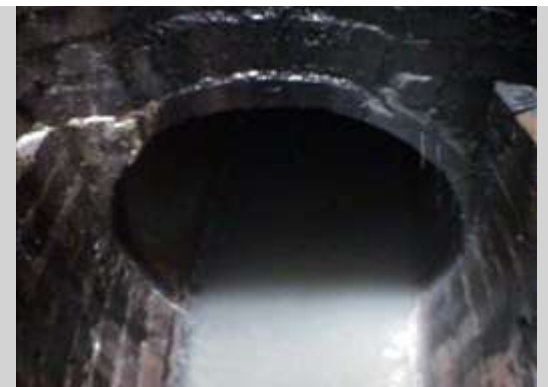
6 O'Clock Inflow

27 in. Circular Gravity Sewer
Pipe In @ 6 O'Clock

Pipe Height: **8.4** (in.) Rod and Bar (Angled)
Pipe Material: **Unknown** ☐ Pipe Lined
Invert Depth: **10.78** (ft.) Flow Characteristics: **Slow**
Deposits: ☒ None ☐ Mud ☐ Sludge ☐ Debris ☐ Grease
Silt Depth: (in.) Deposits Extent:
Infiltration: **None** Pipe Seal Cond: **Sound**

Drop: **Outside** Rod and Bar
Angled: **Yes** Reading: **17.20** (ft.)
Inv Depth: **18.20** (ft.)
Drop Condition: **Open**

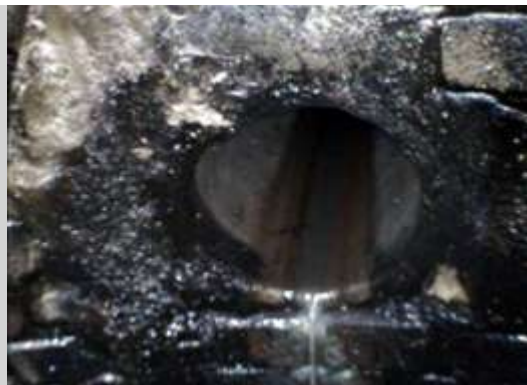
7 O'Clock Inflow

8 in. Circular Gravity Sewer
Drop In @ 7 O'Clock
